## Geological investigation on Ruan Changkul landslide

KAMARULBAHRIN BIN HASHIM<sup>1</sup> AND HENRY LITONG AMONG<sup>2</sup>

<sup>1</sup>Minerals and Geoscience Department Malaysia Sarawak  
Jalan Wan Abdul Rahman 93300 Kuching

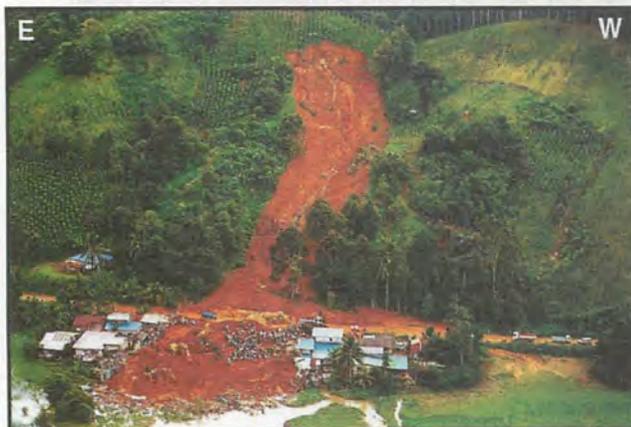
The area is located in the vegetated hill ridge trending east-west direction, bordered by lowland area on the northern part (Fig. 2). Sungai Spaoh is the main river in the region, which flows westwardly. The population of the area is made up predominantly of Ibans, mostly farmers, growing wet paddy in the swampy areas, and pepper and hill paddy in the hilly region. It is hot and humid tropical

Figure 2. Aerial photo of the Ruan Changkul Landslide (Courtesy of Berita Harian).

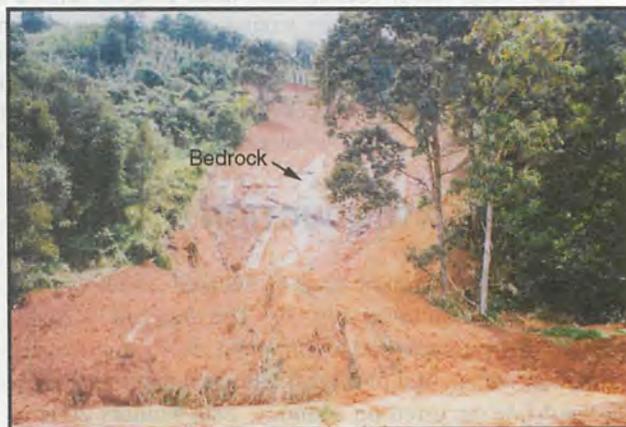
The area is underlain by the Serian Volcanic formation; it consists predominantly of andesite, basalt, limestone and diorite (Haile, 1954) forming the major terrain in this area. Fresh outcrop of highly fractured Serian Volcanic is exposed at the lower part of the affected slope (Fig. 3). Three sets of joint were determined, i.e. 12°/N45°E, 48°/E45°W and 85°/S45°W.

Figure 3. Exposed bedrock of Serian Volcanic.

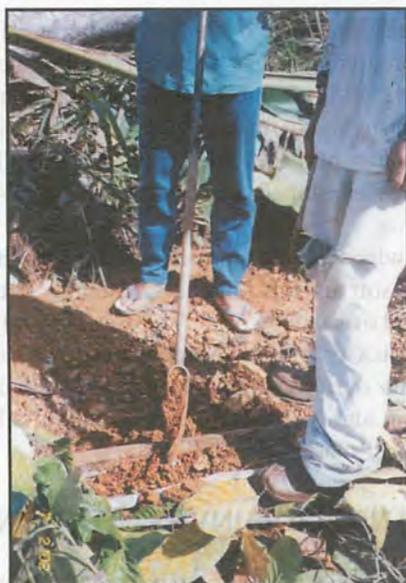
Figure 4. Collecting soil samples using hand auger.

Hand augering was carried out to determine the bedrock-soil contact (Fig. 4). The contact is mainly transitional and defined by a zone of weathered bedrock (Grade V - Grade III). The augering work only characterises the upper softer overburden layer whereas harder bedrock

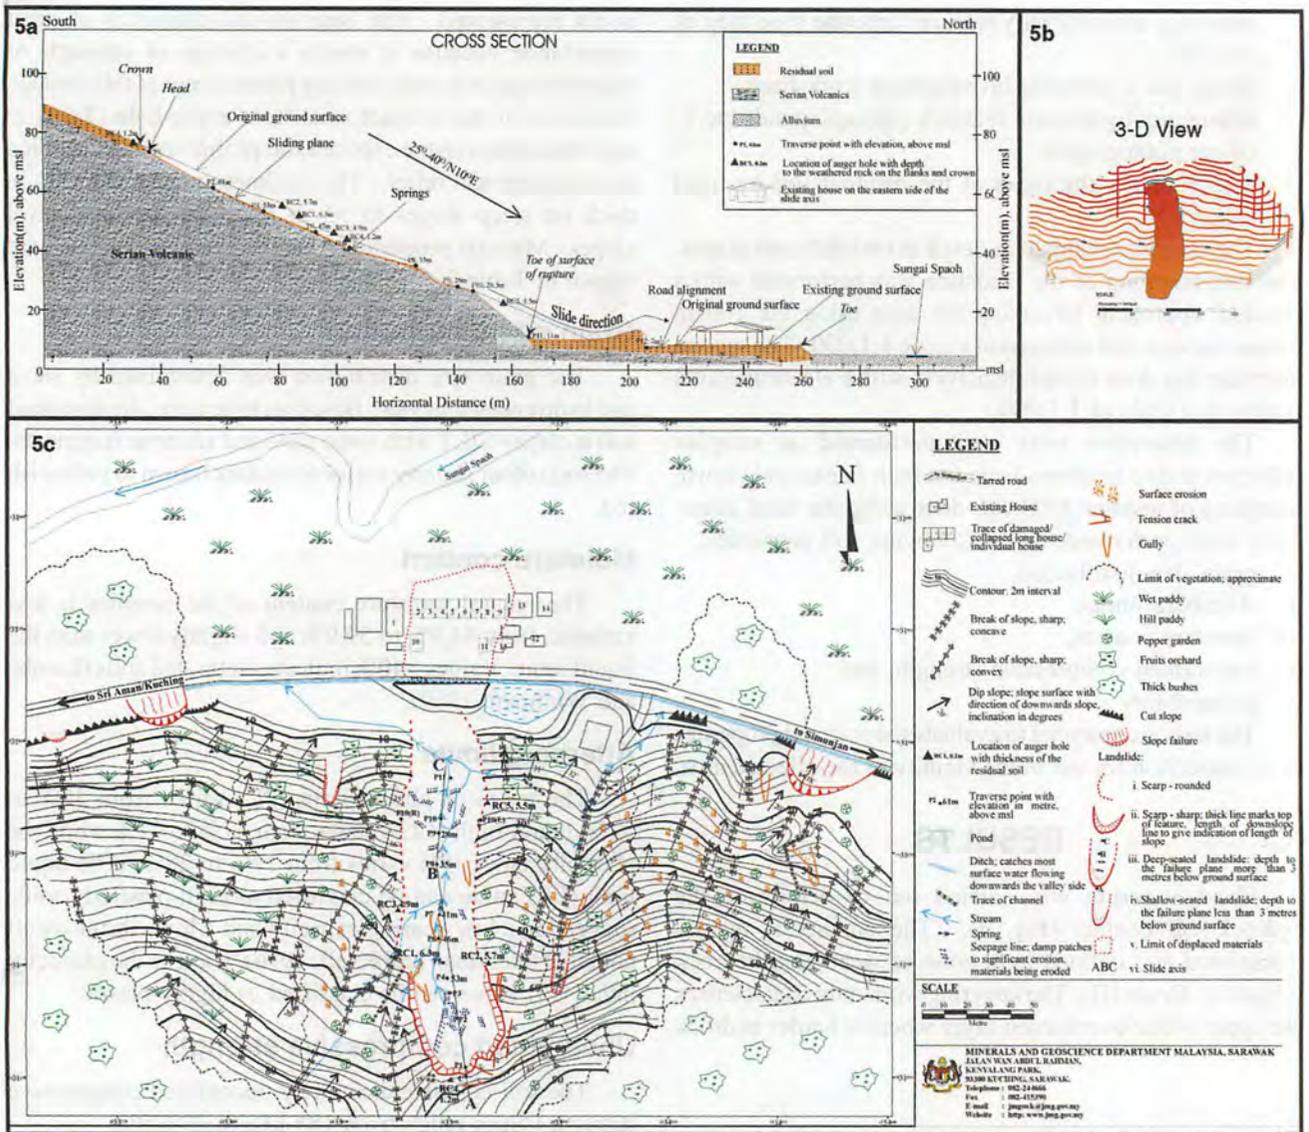
Figure 5. (a) Engineering geology plan of the Ruan Changkul area. (b) Cross section of the area affected by landslide. (c) 3-D view of the affected area.

The landslide occurred on a hillslopes with angles ranging from 25° to 40°. The affected area reached the maximum relief of 76 m above mean sea level (Fig. 5a). The length of the ruptured surface is 170 m long from crown to foot. The maximum width of the scar is 40 m wide whereas the depth to the ruptured surface ranges from 2 m to 9 m deep. The main body is considerably flatter than the top. The failed mass consists of large amount of debris with an approximate volume of 20,000 m<sup>3</sup> to 22,000 m<sup>3</sup> wet slurry, which indicates very high infiltration. The failed mass ends approximately 100 m from the top of surface of rupture to the toe marked by a 3 m drop-off to undisturbed ground at the valley side. Denuded area is oblong bowl-shaped in plan view (Figs. 5b and 5c).

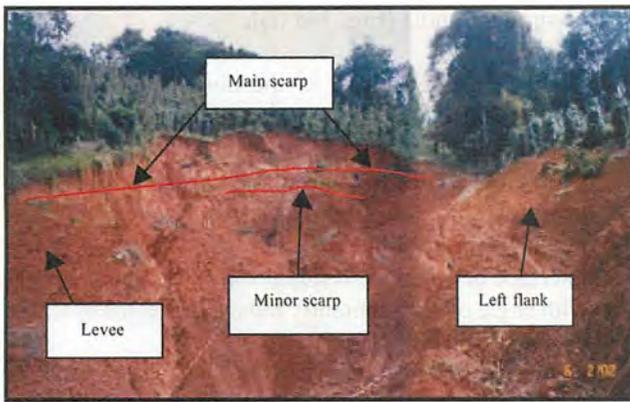
Active features found in the affected area contained the most pronounced morphological changes to the slope. The main scarp is sharp, bare soil escarpment, with concave-shaped, located at the uppermost scarp, approximately between levels 60 m to 70 m above msl (Fig. 6). The main scarp is approximately 30 m wide and 70 m long, with vertical height ranging from 1 m to 4.5 m, steep to near vertical (65°-85°) surface, with no vegetation left standing. Minor scarps were observed within the moving mass and mark the beginning or end of a down drop block or bench (Fig. 6). These scarps are morphologically similar to the main scarp but with length <5 m.

Other prominent features observed are the shear zones forming the right and left flanks (Fig. 6). Both flank

Figure 6. View of the landslide looking up the head scarp.

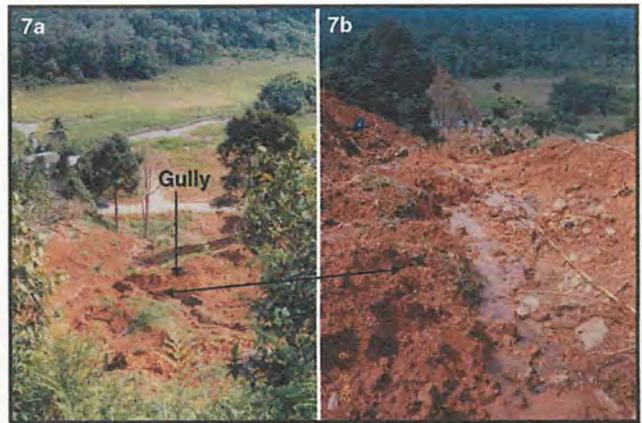
Figure 7. Irregular, gentle to slightly flat main body of the landslide showing a) gully and b) residual soil lobe.

The main body consists of saturated residual soil lobes (Fig. 7). The residual soils lobes are slurry material and non-blocky in nature. These lobes occurred just after the main failure as a result of head scarp, minor scarp, and flank sloughing. Other shear zones appeared as erosional gullies as seen from point P4 to P7 (Fig. 5c) of depth ranging from 0.5 m to 1 m deep and width ranging from 1 m to 2 m wide (Fig. 7).

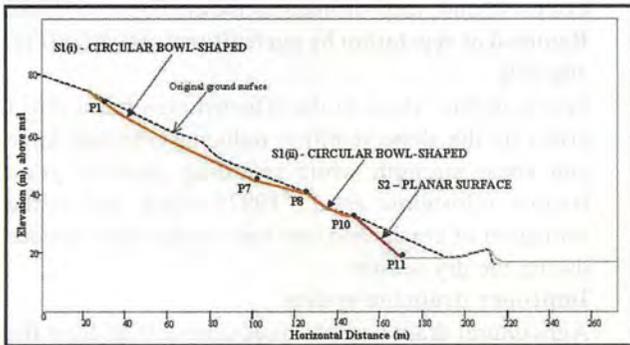
Figure 8. Sliding planes of the landslide.

Two main sliding planes from which the main body descended the slope were identified (Fig. 8), i.e.:

- i. The upper portion, S1(i) from P1 to P8 and S1(ii) from P8 to P10 - is a circular bowl-shaped feature of weathered bedrock. It is steeper ( $>25^\circ$ ) on its upper part, and gentler ( $<20^\circ$ ) in the middle and lower part (P7 to P8).
- ii. The lower portion S2, from P10 to P11 – is a planar surface of fresh bedrock-soil interface, situated at the lower part. This plane is dipping  $40^\circ/N$ , slightly greater than the angle of the original ground surface.

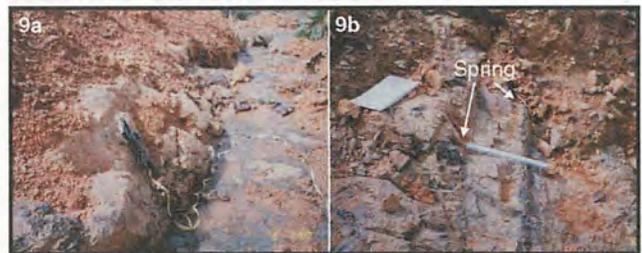
Figure 9. Hydrological features in the main landslide body showing a) stream and b) springs.

There are a few damp and permanent flowing seepage lines and small permanent flowing streams (Fig. 9a) observed throughout the denuded area.

Two spring lines mark the contact between the failure plane and the main body of this saturated zone were identified, located at point P7 (Fig. 9b) on top of a down-dropped bench. These features usually mark a vertical change in conductivity (Richards, 1982). Sag pond, when dry, would appear as a local depression.

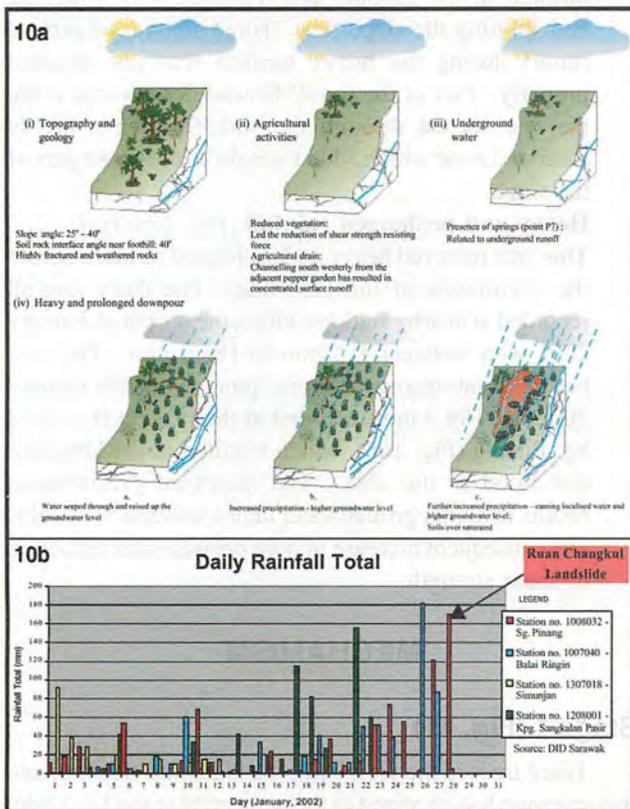
Figure 10. (a) Schematic diagrams of landslide contributory factors. (b) Total rainfall in January 2002 recorded from nearby stations.

- **Topography**  
Elongated undulating concave slopes with angles ranging from  $25^\circ$  to  $40^\circ$  dipping towards the Northwest lying within the catchments area allows accumulation

of surface runoff [Fig. 10a (i)];

- **Geology**  
Highly fractured basalt is the dominant bedrock of Serian Volcanic in the affected area. Fracturing and weathering of the bedrock creates changes in the ground water flow regime (Schultz and Cleaves, 1955). Upper layer of soft and slightly permeable residual soil facilitates infiltration into the slope. Sharp underlying interface between the residual soil and parent material with angle of  $40^\circ$  inherently reduce the factor of safety of the slope [Fig. 10b (i)];

- **Groundwater**  
Presence of springs at point P7 indicates the landslide is also related to the groundwater runoff, which progressively build up the water pores and opened extensive and deep shrinkage cracks (Fig. 10c (iii));

- **Removal of vegetation by agricultural activities** [Fig. 10a (ii)]  
Sparse to bare slope in the affected area has a direct effect on the slope stability, reducing resisting force and shear strength while retarding grain-by-grain friction (Gostelow *et al.*, 1997) which led to the formation of cracks and crevices on the slope surface during the dry season;

- **Improper drainage system**  
Agricultural drain was observed channelling from the adjacent pepper garden into the main body [Fig. 10a (ii)]. Prior to the landslide, concentrated runoff seep through in the channel bed, progressively widening and splitting the slope face. Huge amount of surface runoff during the heavy rainfall was not diverted properly. Part of the runoff flowed downwards while the rest seeped through the soil, forming a highly saturated zone which added weight to the upper part of the slope;

- **Heavy and prolonged rainfall** [Fig. 10a (iv)]  
This area received heavy and prolonged rainfall, before the occurrence of the landslide. The daily rainfall recorded at nearby stations within the month of January 2002 were between 0.5 mm to 185.0 mm. The area had the greatest amount of precipitation on 28th January 2002 i.e. 169.9 mm recorded at the nearest station of Sg. Pinang (Fig. 10b), which resulted in the landslide and flood in the area. The increased precipitation results in higher groundwater tables, saturation of soils, and consequent increase in pore pressure and reduction of shear strength.

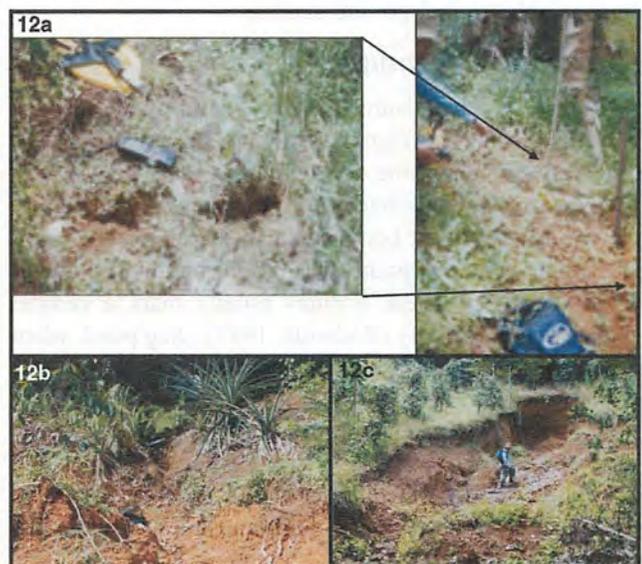
Figure 12. Features related to slope movements indicating slope instability near the major landslide area. (a) Tension cracks. (b) Gully. (c) Minor slide.

Based on the investigation in the area, geomorphological and geological conditions are fairly homogeneous over the mapped areas. Ruan Changkul and the surrounding areas can be classified as a landslide prone area and exposed to the occurrence of the landslide. There are signs of slope instability in the adjacent areas such as tension cracks, erosions, soil creeps, gullies, slope failures and minor slides (Fig. 12). Tension cracks were found on the ground surface along the crown and flanks, outside the main landslide zone. The cracks are signs of the instability prior to the catastrophic landslide. Three prominent large cracks were observed in the ground very close to the upper right flank perpendicular to the contour with an approximate 1 m to 2 m long and 10 cm to 20 cm opening (Fig. 12a). Two cracks, which are 0.5 m apart, are located on the crown. Each crack has an opening of 30 cm.

Measures should be taken to prevent further slope movements in the areas that are vulnerable to the slope movement and among the measures suggested are as follows:

- Erosion control. Slope reduction by grading or terracing, including buttressing and retaining systems such as riprap or gunnite to protect the base of slope. Restrictions on land use should be imposed and enforced by local governments by means of land use zoning and regulations;

- Control of water movement on or within slope (provide adequate drainage) – proper drainage system should be build to contain excessive surface run-off and localised concentration;

- Refill crevices and other openings to prevent water from obtaining access into the ground. Covering the barren slope surface with plastic sheets as a temporary measure;

- Planting of vegetation. Plant more trees with 'anchoring' roots as a long-term prevention;
- Issue of warnings. Hydrologic conditions such as heavy precipitation can be forecasted with some certainty, warnings can be issued to areas that might be susceptible to slope movement;
