Guidelines to prevention of slope failure related disasters in granitic bedrock areas of Malaysia

J.K. RAJ

Department of Geology, University of Malaya
50603 Kuala Lumpur

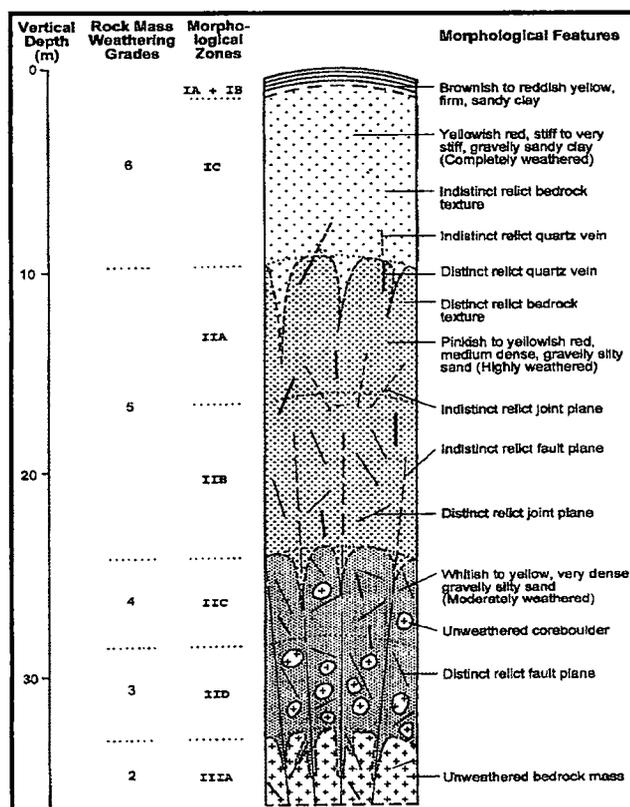
Figure 1. Weathering profile over porphyritic biotite granite.

In the case of a typical weathering profile over a porphyritic biotite granite (Fig. 1), the topmost morphological Zone I (weathering Grade 6) is up to some 12 m thick and consists of completely weathered bedrock that indistinctly preserves the textures, but not structures, of the original bedrock. The weathered materials have been subject to pedological processes and can be separated into an upper, sandy clay IA horizon (<1 m thick), an intermediate, sandy clay IB horizon (<2 m thick) and a lower, stiff to very stiff, gravelly sandy clay, IC horizon (up to 10 m thick). Consolidated, drained triaxial tests on undisturbed, and remoulded, samples from the IC horizon,

Morphological Zone II (comprising weathering Grades 3, 4 and 5) is up to 30 m thick and consists of *in situ* moderately to highly weathered bedrock that indistinctly to distinctly preserve the minerals, textures and structures of the original bedrock; the degree of preservation increasing with depth. This Zone can be separated into four horizons; the top two horizons IIA and IIB consisting mainly of loose to medium dense, gravelly silty sands with distinct relict textures and quartz veins, but indistinct relict structural discontinuity planes. The upper IIA horizon is up to 6 m thick and devoid of coreboulders, whilst the lower IIB horizon is about 5 m thick and contains a few partly weathered coreboulders. In the lower horizons IIC and IID, unweathered coreboulders are prominent and separated by thin to broad, bands of medium to very dense, gravelly silty sands showing distinct relict textures and structures. The coreboulders form up to some 50% by area of horizon IIC (about 5 m thick), but constitute more than 70% of the IID horizon. Consolidated, drained triaxial tests on undisturbed, and remoulded, samples of the medium to very dense, gravelly silty sands from Zone II, and from other similar Zone II, mostly only yield f (angle of internal friction) values of between 35° and 38° (Raj, 1983).
